AVIATION SAFETY DIGEST

DEPARTMENT OF CIVIL AVIATION

No. 44

DECEMBER, 1965

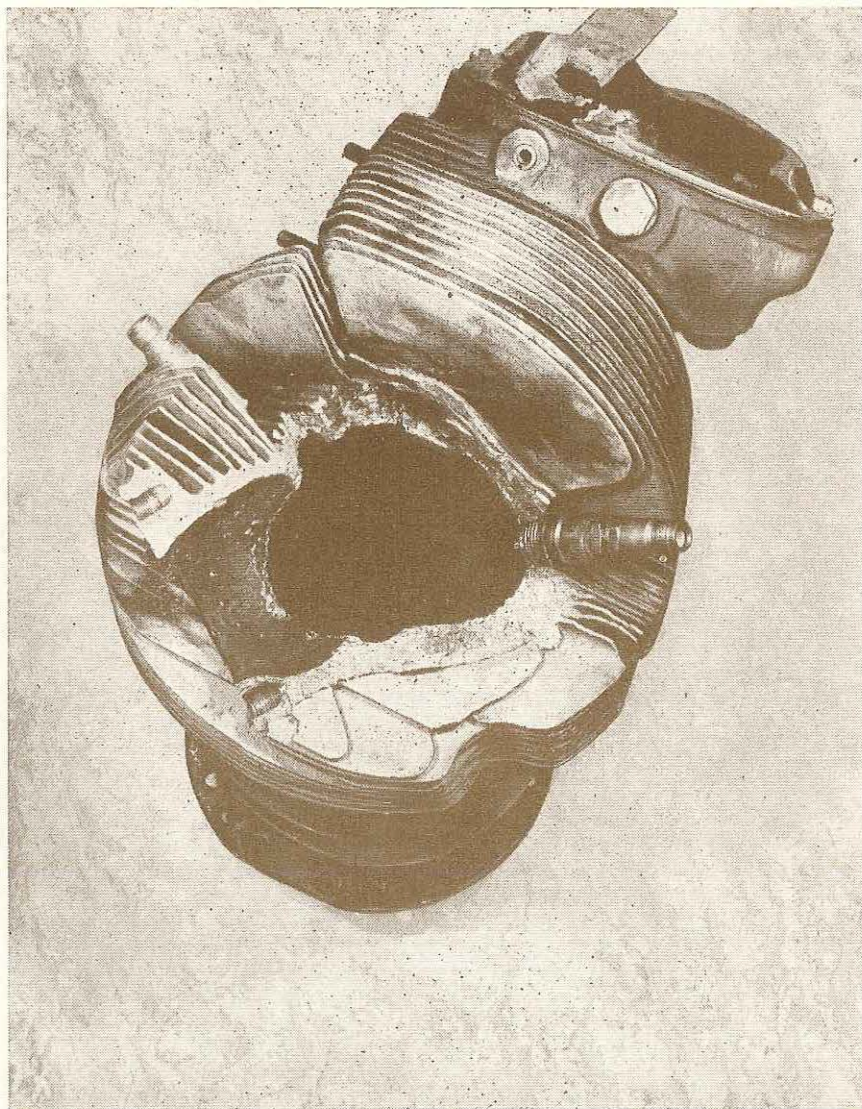
A detailed examination of the starboard propeller established that at the time of the major impact it was rotating with the blades on the fine pitch stops. Further inspection of the failed starboard engine established that the No. 7 cylinder inlet valve stem had fractured across the valve retaining collet groove, allowing the valve to drop into the cylinder, where it was hammered by the piston until the cylinder head failed. A laboratory examination established that the valve stem fracture was caused by fatigue cracking. The valve had been in service for a considerable period and the fatigue failure was attributed to normal operating stresses over an extensive service life. No defects were found in the engine other than the structural damage to the No. 7 cylinder assembly. It was evident that the valve stem had failed during or immediately after take-off and that the engine had continued to run until the aircraft flew into the ground. In this condition, the engine would have been capable of delivering about 800 shaft horsepower, 67 per cent. of the power normally available for take-off.

The failed No. 7 cylinder head removed from the starboard engine
