AVIATION SAFETY DIGEST

DEPARTMENT OF CIVIL AVIATION

No. 44

DECEMBER, 1965

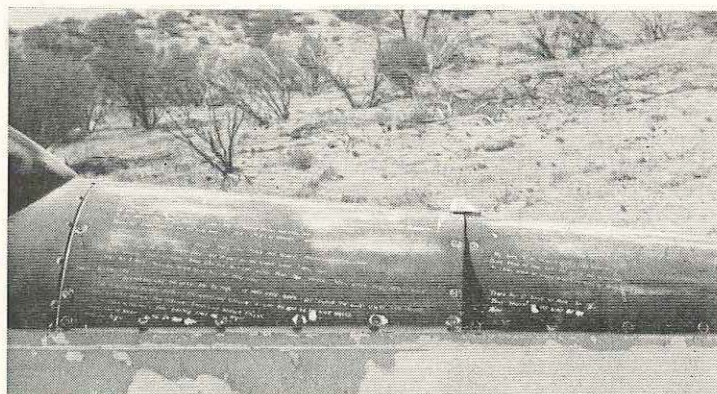
They found the Wackett resting normally on its wheels in the red sand at one end of the clearing between two parallel ridges. At first glance it appeared intact, and it was only after a closer look that impact damage was evident. The pilot had obviously made a powered approach from the west into the 300-yard clearing and had ground-looped to starboard as the aircraft had run into thickening scrub and spinnifex at the eastern end. The flaps were still fully down, the starboard one damaged from having ridden over a small mulga tree, and the scrub had torn the fabric in places as the aircraft jolted to its final resting place. The three years of exposure to the scorching sun and the wind had also taken its toll; the paintwork was blistered, in places the wind-driven sand had eroded the finish down to bare metal and the rudder hinges had succumbed to their many months of flapping in the winds. Four scattered seat cushions, a piece of blanket, the remains of a signal pegged out on the ground, and a day to day diary scratched on the fuselage panels behind the rear cockpit, poignantly told the story of the pilot's agonizing wait for the rescue aircraft that never arrived, but apart

from a note suggesting that the front cockpit compass could have been 30 degrees out, they offered no explanation for his gross navigational error. Both compasses had been dismantled.
